**Force Engineering & Testing Inc.**

Project Number : 13-0328T-06A

Test Protocol : TAS 125-03  
PER ASTM E 1592-01  
*STANDARD TEST METHOD FOR THE STRUCTURAL PERFORMANCE  
OF SHEET METAL ROOF AND SIDING SYSTEM BY UNIFORM  
STATIC AIR PRESSURE DIFFERENCE*

## **TOPHAT SYSTEM**

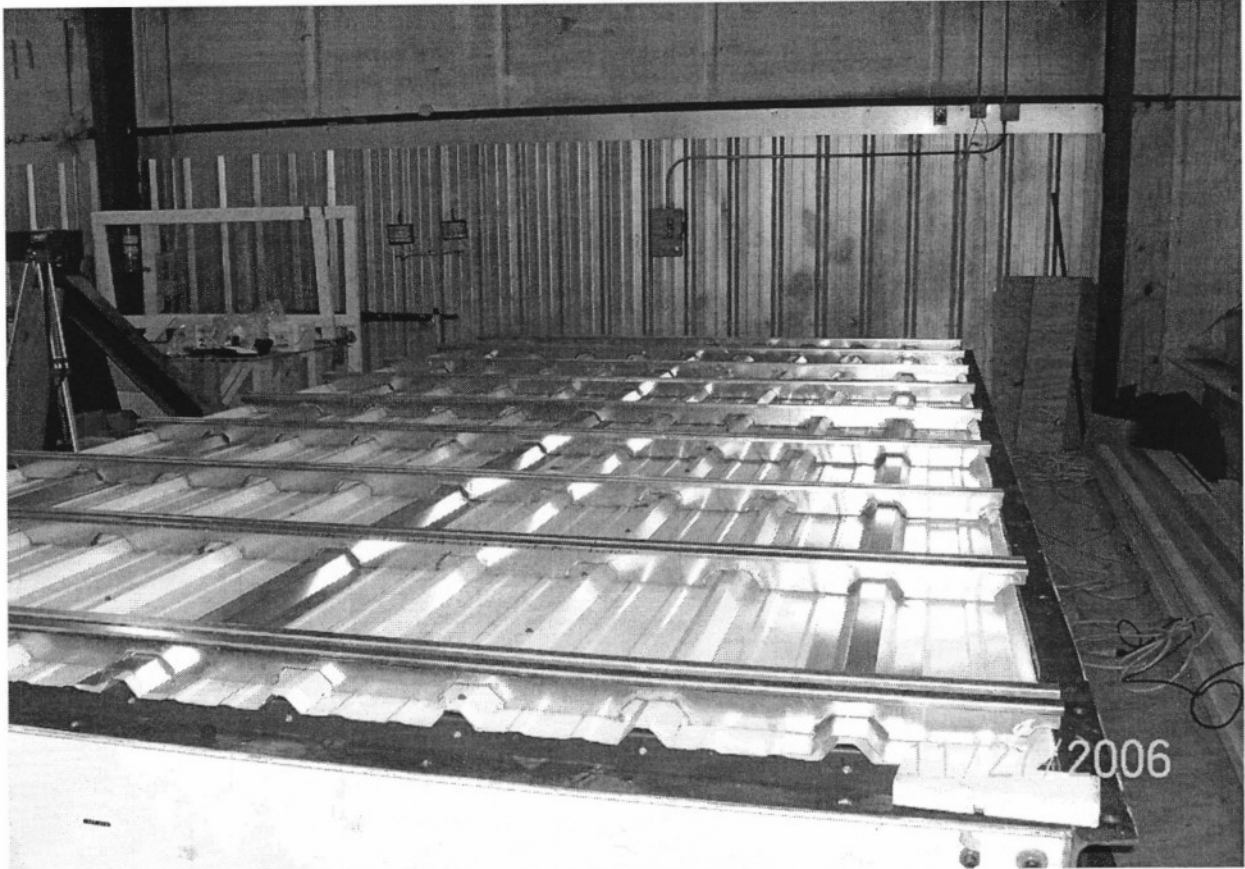
**TOPHAT @ 2'-6" O.C., HATS @ 4'-0" O.C.**

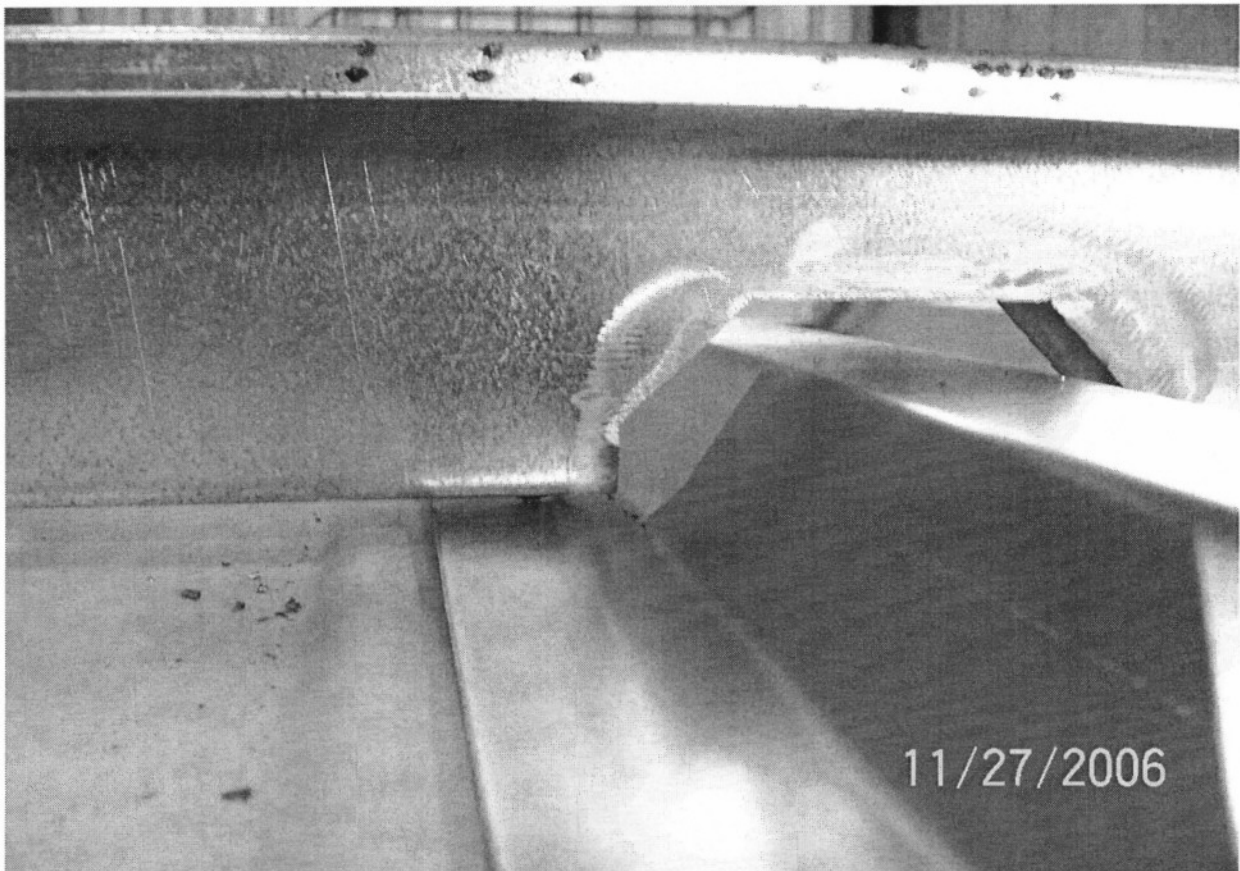
The panel assembly reached a maximum sustained test pressure of -200.0 psf and an ultimate test pressure of -210.0 psf. The failure mode was the roof runner fasteners pulled out of the 16 Ga. hat.

**Ultimate Test Pressure:** 200- psf  
**Mode of Failure:** TopHat Fasteners Pulled out of hat

**ASSEMBLY AFTER TESTING, TOPHAT PULLED OUT OF HAT SUPPORT**
